Special Issue:
**Pipeline
Technology**

Fracture mechanical properties of polyolefins: Do the standards specify realistic areas of application?

By H.-J. Kocks, C. Bosch and M. Betz

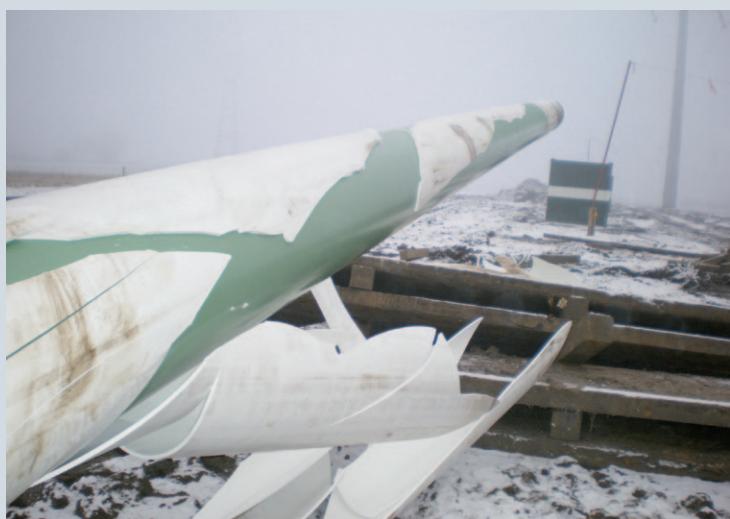
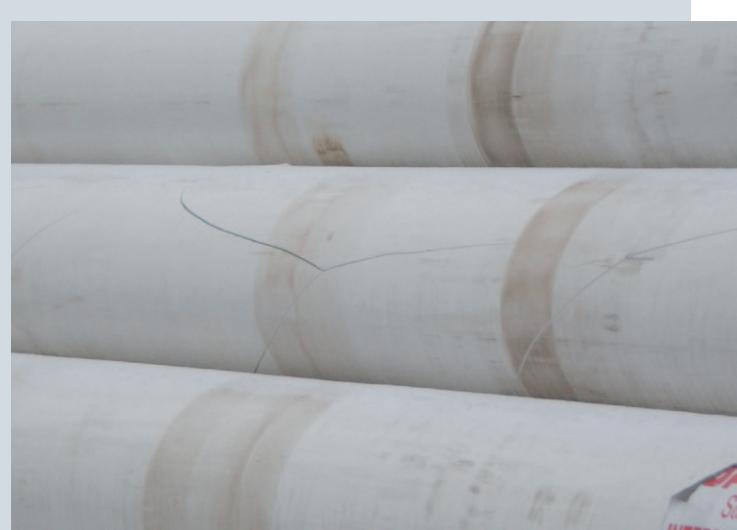
FIGURE 1 AND FIGURE 2: PP coating damage discovered on a buried pipe and pipes on stock

Polypropylene coatings are known to fail under low ambient temperatures. Figures 1 and 2 show examples of such a case of damage. The pipeline was buried by means of horizontal directional drilling (HDD). The pulled end of the pipe extended beyond the hole and showed clear signs of flaking after a period of cold weather at -10 °C to -15 °C (Figure 1). Even some pipes on stock revealed first cracks (Figure 2). When exposed to a hammer stroke at -4 °C, undamaged pipes on stock also showed this cracking. When the 3-layer PP coating was examined, it was found to meet all quality requirements. The data sheets of the special type of polypropylene used in this case specified a glass transition temperature of -40 °C. Standard impact testing to DIN 30678 at -20 °C did not lead to any coating failure. Taking account of the operating temperature of -20 °C to +110 °C specified by ISO 21809-1, another method of testing was required in order to realistically assess the area of application of such coatings.

If applied to a material become brittle due to low temperatures, the aforementioned impact test to DIN 30678 should have revealed major flaking or cracking such as was found on pipes on stock at -4 °C. At a closer look, the impact test array to DIN 30670 or DIN 30678 is not really

Investigations show that the type of PP normally used for pipeline coating does not support temperatures down to -20°C as described in ISO 21809-1. The results suggest to preliminarily restricting handling and installation of 3-layer PP coated pipes to temperatures of 0°C . In a general sense, this restriction is covered by DIN 30678 pointing to the basic need for an impact resistance test at this temperature. Whereas the last version of ISO 21809-1 will not include this aspect, it was possible to make readers aware of the susceptibility to low temperatures by adding a footnote concerning the handling and installation of pipes.

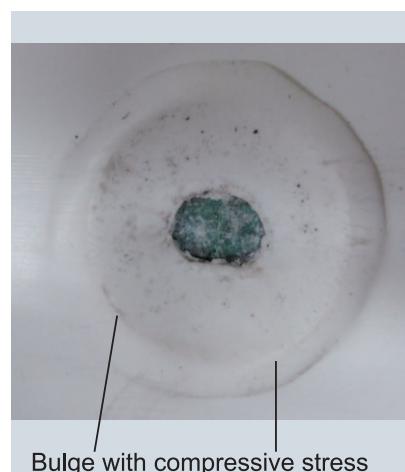
suitable for such investigations. The test impact is applied with a drop weight exhibiting a hemispherical head. According to the standard, the diameter of the hemisphere is 25 mm. Since the head of the drop weight is hemispherical, the coating material is pushed towards the edges of the test area as the weight hits the test object. The ensuing bulge generates compressive stress in the area that cracks should have formed in (Figure 3).

FIGURE 3: Coating after conventional impact test

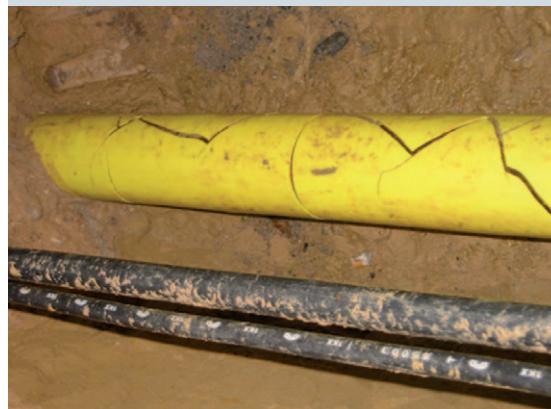
Under mechanical aspects, cracking therefore has identical causes, which is confirmed by comparing the fracture patterns of these failure modes (Figures 9 and 10). In both cases, cracks on the pipe form in the same way.

FIGURE 9:
Cracking pattern as produced by aging of the material

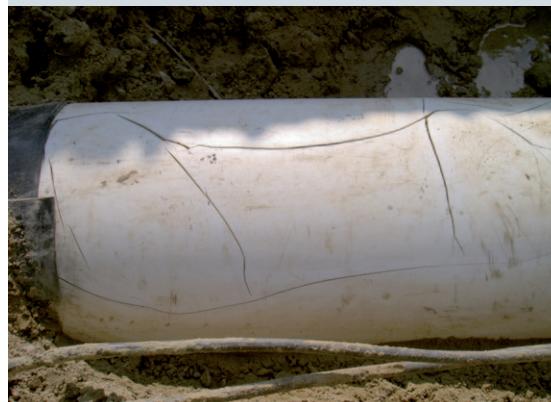
FIGURE 10:
Cracking pattern as produced by low-temperature embrittlement

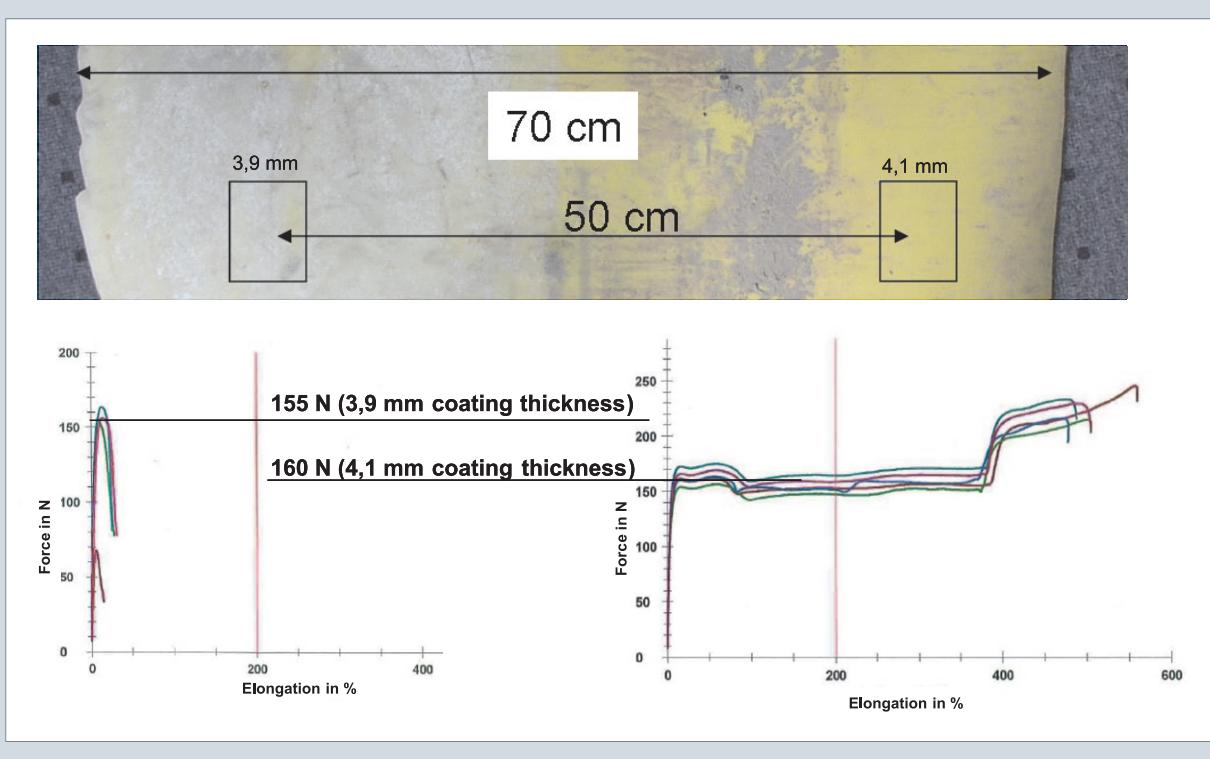
FIGURE 11:

Practical experience provides facts excellently documenting this interconnection with regard to cracks forming when UV light damages a polyethylene coating. Figure 11 illustrates the mechanical investigations performed on a section where the material was peeled off from the entire circumference of the pipe. The damaged section is inevitably restricted to the side exposed to the sunlight and can be recognized in Figure 11 by the colour change from yellow to colourless. The underside remains undamaged. In the damaged sections discolouring was not only observed on the surface of the PE-layer, at least 1/3 of the layer thickness was discoloured.

The yield stress remains at about 155 N to 160 N in both the damaged and undamaged sections and only varied due to different coating thicknesses. In the damaged sections tensile stress at break and elongation at break have much lower values than in the undamaged sections. This is to show again that the tensile stress at break decreases as UV damaging increases. As the tensile stress at break decreases, the ratio of tensile stress at break and yield stress becomes more unfavourable and the elongation at break reaches its limit. These results gained from practical applications again confirm the interconnectedness of yield stress and tensile stress at break and its impact on the material's strainability and, thus, its flexibility.

Analysis of a steel pipe coating damaged by UV light - tensile tests
