# Stress corrosion cracking of polyethylene – practical examples of steel pipe coatings

By Hans-Jürgen Kocks

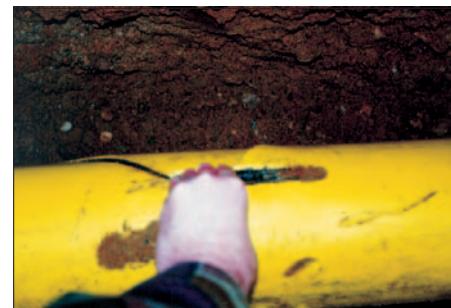
**Fig. 2:** Cracking due to mechanical stresses

This type of cracking occurs as a result of mechanical impact, completely irrespective of any aging process. The extent of the damage caused will largely be determined by the residual adhesion of the polyethylene coating to the steel pipe. Figure 2 shows a typical example of damage caused by an excavator tooth. In addition to damaging the polyethylene layer, the excavator tooth also exerted considerable pressure on the coating as a whole.

The resulting stress generated two approximately 1-metre cracks which propagated to either side of the coating holiday. The steel pipe remained unaffected thanks to its high mechanical strength. The polyethylene coating is a two-layer system with a bituminous adhesive of the type used as standard in the 1970s. The peeling resistance and the bonding strength of the adhesive were significantly inferior to the systems used later.

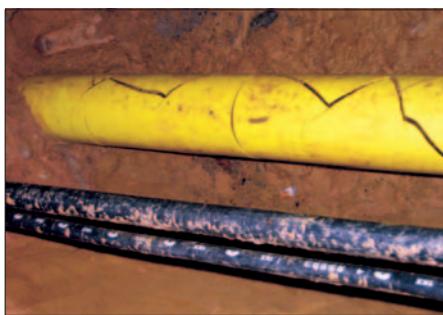
Fig. 3: Polyethylene coating damaged by embrittlement

ble damage mechanisms of polyethylene have to be considered, such as light or heat aging, oxygen-induced embrittlement, and stabilizer degradation. Figure 3 shows the branched cracking typical of this type of damage. The coating, which was produced in 1978, was found to have suffered a significant drop in elongation at break, reaching a mere 25 % on average (Figure 4).

For this kind of cracking to occur, the stress acting on the coating must have locally exceeded the allowable stress specified for the material. The drop in elongation at break is a clear indication of aging and thus corrosion of the polyethylene. However, the residual elongation is still far higher than the strain acting on a material combination of PE and steel during normal pipe-laying, where impermissible point supports or loads lead to local constraint which, in turn, promotes crack formation. Even though, in most cases, this kind of damage means that rules or codes of practice have not been observed, the possibility of determining the aging behaviour of polyethylene in significant tests as a basis for optimizing its service characteristics would still be welcome.

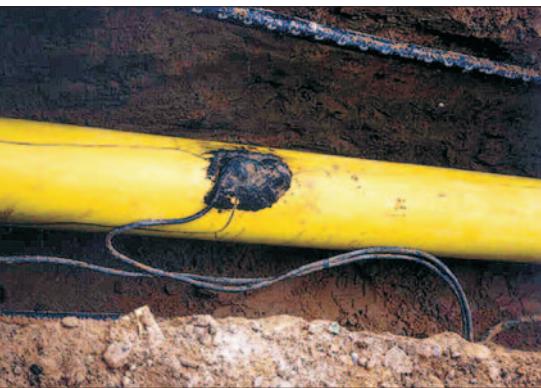
**Fig. 5:** Stress cracks as a secondary damage in inadequately field coated connections for cathodic corrosion protection

Apart from the well-known stress corrosion cracking types described above, there have been cases of cracking in polyethylene whose origin could not be attributed to a combination of mechanical stresses and material embrittlement. In phenomenological terms, this damage type can be described as long-running cracks in a coating whose elongation at break nevertheless still corresponds to the as-manufactured condition (Figure 5 and 6).

- The pipes are coated with a two-layer system.
- The crack goes through the coating, right through to the steel surface.
- The coating holiday exhibits notch tips, e.g. in the form of knife cuts.
- The pipeline features cathodic corrosion protection.

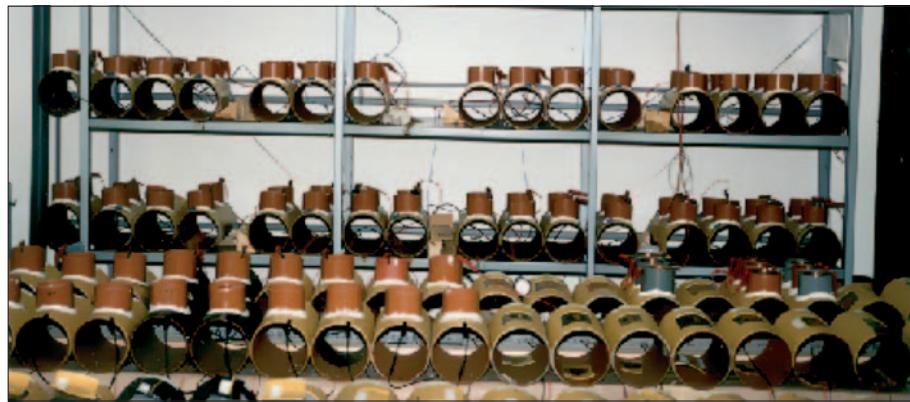
Fig. 7: Test stand for examining cracks in polyethylene coatings

The polyethylene-coated pipe specimens were manufactured under standard production conditions. For the stress cracking investigations, the polyethylene coating was

cut through to the steel surface and completely removed over a length of 40 mm. The sharp-edged carpet knife used for this purpose was fitted with a new blade after each cut. On the polyethylene-coated segment, a piece of PVC pipe was positioned around the site of the cut as a vessel for the test solution (**Figure 7**). The specimens were exposed to this solution at room temperature. They were checked daily and the time of crack initiation was documented.

To simulate the service conditions of a cathodically protected pipeline, the steel surface was polarized to -1.5 volt with the aid of a calomel reference electrode.

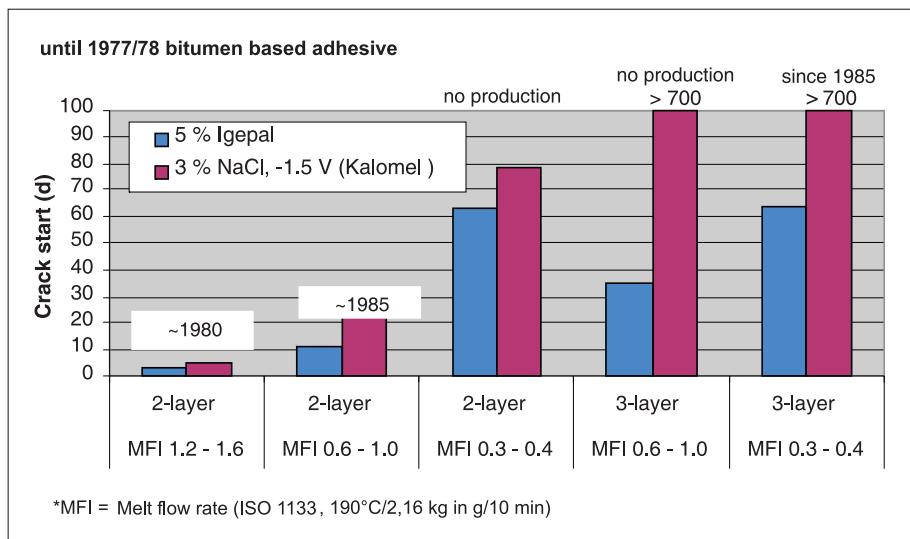
Fig. 8: Investigations into the effect of the melting index and coating structure on the time of crack initiation

One of the key objectives of this investigation was to determine the effects of influencing parameters such as the coating structure and the polyethylene types used in the past. **Figure 8** shows the most important findings of the relevant laboratory tests.

Two different coatings systems were included in the investigations. These were the two-layer system with an adhesive based on polyacrylic resin and a polyethylene top layer, and the three-layer system consisting of an epoxy resin primer, an acrylic acid / acrylate modified PE copolymer adhesive, and a top layer of polyethylene. In addition, three LDPE types with different melt indices were used. The decreasing melt index in this case is mainly due to the increasing chain length of the polyethylene types used. The time of crack initiation in the presence of a wetting agent and on exposure to the salt solution in combination with cathodic corrosion protection correlates only for the two-layer PE coatings. These systems clearly show that the resistance to stress corrosion cracking increases with increasing chain lengths (Fig. 8). In the case of three-layer systems, no sign of stress corrosion cracking was observed even after 700 days' exposure and irrespective of the polyethylene type used. When evaluating the test results it should be borne in mind that neither the two-layer system with the polyethylene type in the melt index range of 0.3 to 0.4 nor the three-layer system with the polyethylene type in the melt index range of 0.6 to 1.0 have ever been used in a real project.

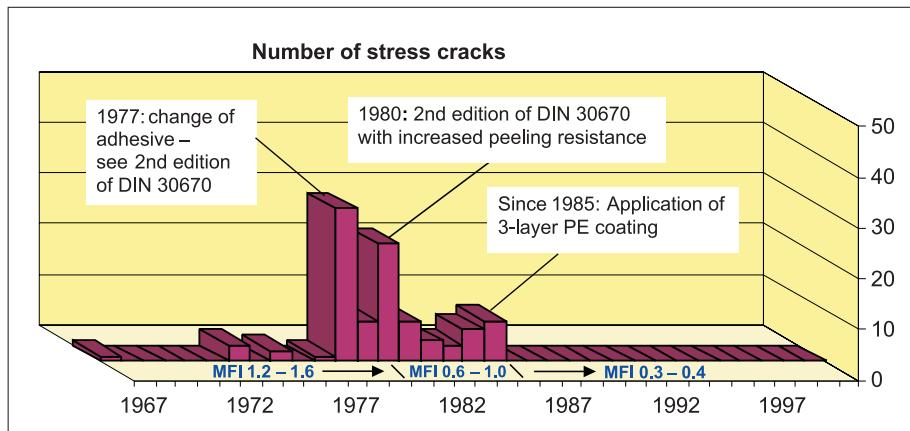
Fig. 9: Number of reported damage events per year and coating system

**Figure 9** shows the number of damage events reported over the past 20 years per production period and polyethylene coating type. Strikingly, stress cracking damage of this kind was hardly known before 1977. The PE types most susceptible to stress corrosion cracking were used regularly up until about 1980. Even more important, the adhesive type changed from 1977 onwards, because the publication of the revised DIN 30670 edition meant higher requirements had to be met regarding peeling re-

sistance. A bitumen-based adhesive was used up until 1977, when it was replaced with a polyacrylate based adhesive. Suddenly, the number of damage events increased dramatically. From 1981 onwards, a PE type in the melt index range of 0.6 to 1.0 and with higher resistance to stress corrosion cracking was used in conjunction with the same adhesive type and coating structure. The number of damage events reported for this production period is significantly lower.

In the mid-eighties, the system that is still standard practice today – the three-layer PE coating with additional epoxy resin primer – was introduced in Germany. Since the change-over to the three-layer system with polyethylene types in the melt index of 0.3 to 0.4, no more damage events involving stress corrosion cracking of the described nature have occurred.

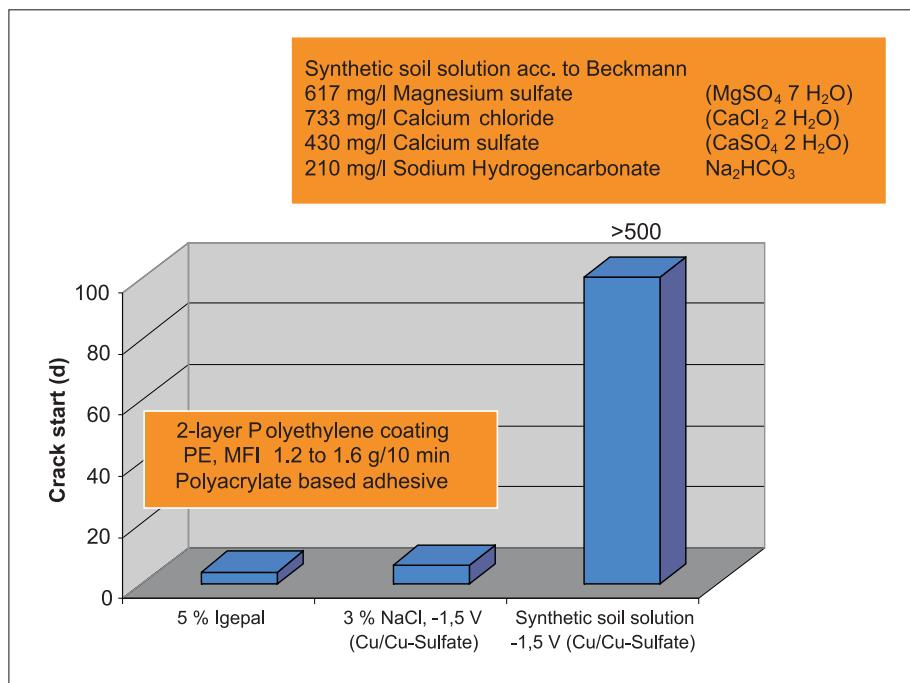
**Fig. 10:** Stress crack initiation in various test media

**Figure 10** illustrates the influence of the soil medium on stress corrosion cracking. The polyethylene coating considered here is the most susceptible two-layer system with a melt index in the range of 1.2 to 1.6. While the specimen exposed to the wetting agent solution without cathodic polarization already showed stress corrosion cracking within three days, the specimen under cathodic polarization in the salt solution failed after five days. In the synthetic soil solution according to Baeckmann, no sign of cracking was observed even after 18 months.

It was thus proved that alkalinity together with cathodic polarization as well as the soil properties in the area of a coating holiday are major factors in the type of stress corrosion cracking investigated here. In salt solution, sodium hydroxide is generated primarily at the site of the coating holiday while, in the case of the synthetic soil solution, the buffer effect of hydrocarbonate prevents high pH-values and thus stress corrosion cracking.

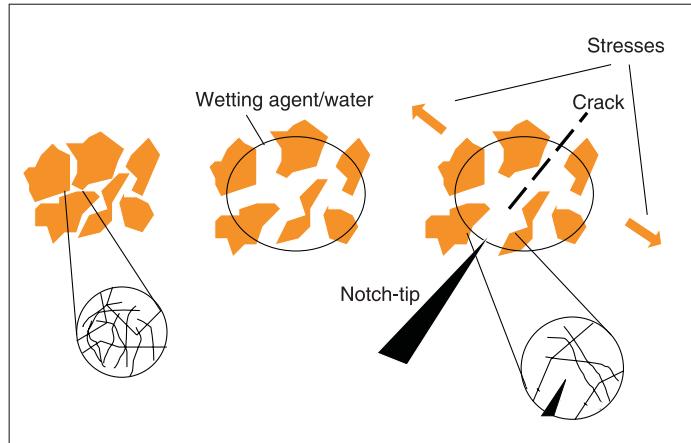
**Fig. 11:** Particle theory

ethylene components, have been discussed in previous reports [7]. A generally accepted description of the stress cracking mechanism is provided by the particle theory (**Figure 11**).

Given that crystalline regions (particles, crystallites) are primarily held together at the boundaries by entangled molecular chains (crystal bridges), the presence of wetting agents and stresses will cause this structure to expand or swell. At this stage, expansion is still reversible. However, if there is a notch, cracks may be initiated by disentangled molecular chains. Crack initiation and the speed of crack propagation will be a function of the chain lengths, local stresses in the notch tip, and the type of wetting agent used. This form of cracking is triggered by a chemical reaction, i.e. a diffusion controlled pro-

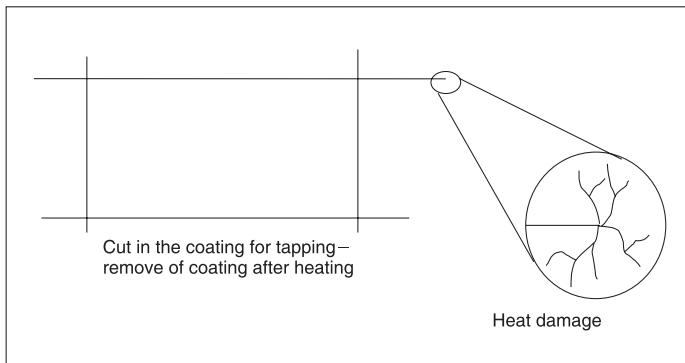
**Fig. 12:** Notch effect caused by an inappropriate cut into the coating incision when making a service connection

Apart from major impacts through the likes of an excavator tooth or an accidental blow with a pick, normal work such as the installation of service connections has provided ample opportunities for damage to the coating in the form of holidays with a notch effect. Although technical rules for the installation of service connections stipulate expressly that the coating be removed with a single circular cut, it happens very frequently that four cuts are made (**Figure 12**) for this purpose. Given subsequent thermal damage by the burner normally used for loosening the top layer, possibly in combination with inap-

propriate field coating, the end points of these cuts serve as crack initiation sites for the kind of stress damage discussed here.

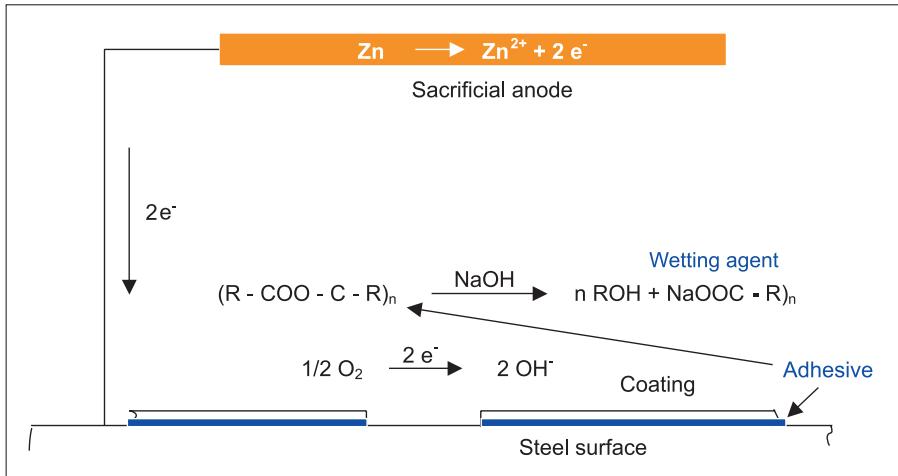
**Fig. 13:** The effect of cathodic corrosion protection

system, a high pH value led to local saponification of the adhesive and hence to the generation of wetting agents (alkalis) in the area of the steel surface. This mechanistic approach is confirmed by the correlation of the laboratory results for two-layer coating systems under cathodic polarization in salt solution and in the presence of wetting agents.

To understand the generation of the wetting agents required for the occurrence of stress cracking, it is necessary to take a closer look into the effect of cathodic corrosion protection on a coating defect which penetrates to the steel surface. The most important electrochemical reactions to be considered in the area of coating holidays in a cathodically protected pipeline are shown in **Figure 13**.

The steel pipe to be protected is electrically coupled to the sacrificial anode which consists of a less noble metal. Due to the difference in potential, an excess of electrons is generated in the steel, which prevents its iron content from reacting with the soil and dissolving. At the site of a coating holiday, the excess electrons promote the reaction of oxygen into hydroxide as a cathodic partial reaction. The anodic partial reaction is shifted to the sacrificial anode which is installed at a remote site. A properly functioning cathodic protection system will indicate coating holidays by intensive alkali hydroxide formation which, in turn, leads to a rise in the pH value of the soil medium. With a two-layer

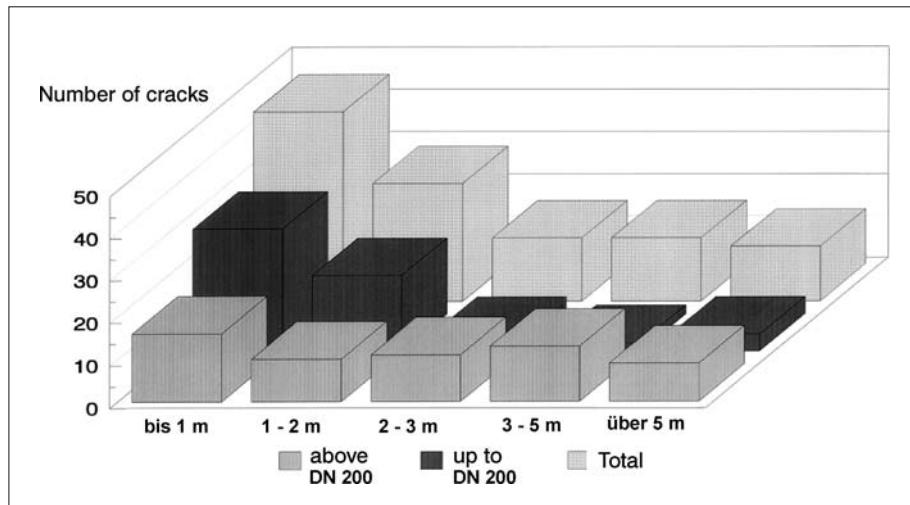
Fig. 14: Comparison of crack lengths as a function of pipe size

For an assessment of stresses in polyethylene coatings, another glance at the damage statistics will be helpful. **Figure 14** shows an evaluation of damage events in terms of crack lengths measured in the polyethylene coating. Most of the cracks remain within the length range of up to 2 metres. Further evaluation of the damage cases in relation to the pipe dimensions reveals a significant increase in the number of long cracks for pipe sizes greater than DN 200 (Fig. 14). Obviously the stresses are higher in these pipes than in the smaller pipe sizes.

Looking at the production conditions, the origin of residual stresses in polyethylene coatings is quite clear. The pipe cooling rate is decisively governed by the pipe wall thickness and diameter as well as by the speed of the coating process. The different coefficients of thermal expansion of steel and polyethylene also play a special role. Residual stresses are apparently most marked in the larger pipe sizes.
