Sense and nonsense of service-life statistics

Condition-based maintenance of cathodically protected steel pipelines

By Hans Gaugler and Dr. Hans-Jürgen Kocks

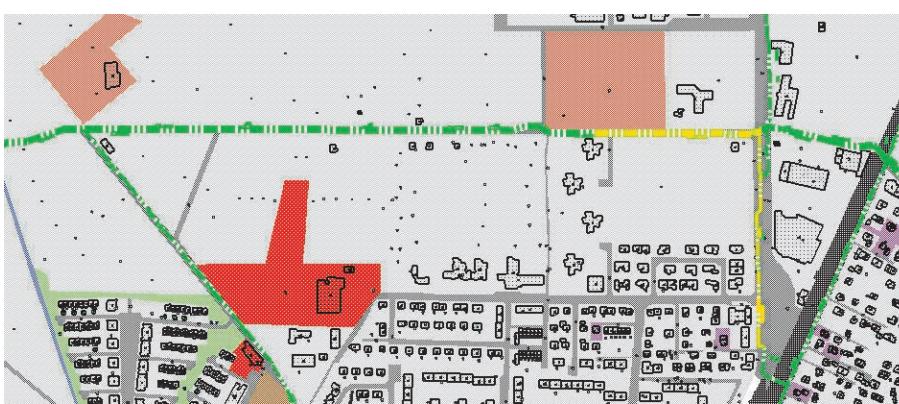
Fig. 7: Route map of the pipeline section with damaged coating (highlighted in yellow)

Crack formation leads to a reduction in the electrical insulation resistance of the Coating. Possible consequences are an impairment of the effectiveness of the CCP and impermissible electromechanical interference with adjacent objects. Corrosion protection measurements along approximately 7400 m of this pipeline (Fig. 6) show that, apart from a few isolated dot-shaped holidays which probably date right back to the laying of the pipeline, the coating is in excellent condition. The diagram of the measurements along the remaining approximately 600-m section (Figs. 7 and 8) show a very different picture indeed.

The coating is in poor condition. The pipeline section in this district is exposed to heavy and dynamic traffic loads. Roadworks and pipe-laying operations carried out in the past have only added to the damage. Based on the measured

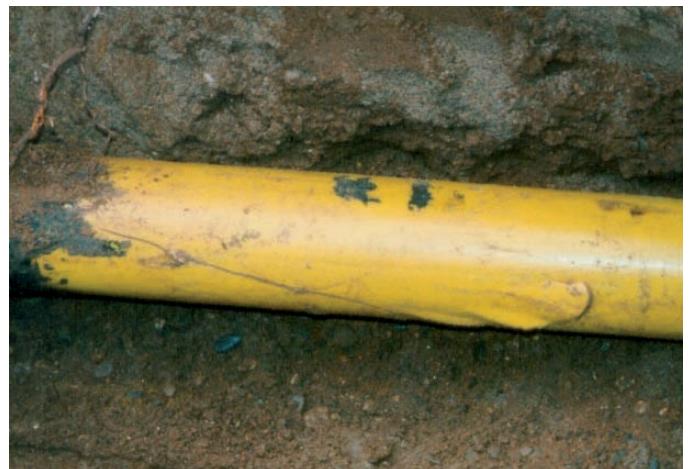
Fig. 9: Example of a coating fault caused by external influences

The formation of such cells is only possible where the pipe coating suffers damage as a result of negligence when the pipe was being laid or other external influences. The higher number of damage incidents observed here supports the conjecture that their origins mostly go right back to the pipe laying. When external cathodes, e.g. steel in concrete, can be activated, the decisive factor for the corrosion rate is the cathode-to-anode area ratio. Here the comparatively small areas of buried steel which are unprotected due to coating damage (Fig. 9) form the anode. Figure 10 shows the extent of the area an external cathode can cover.

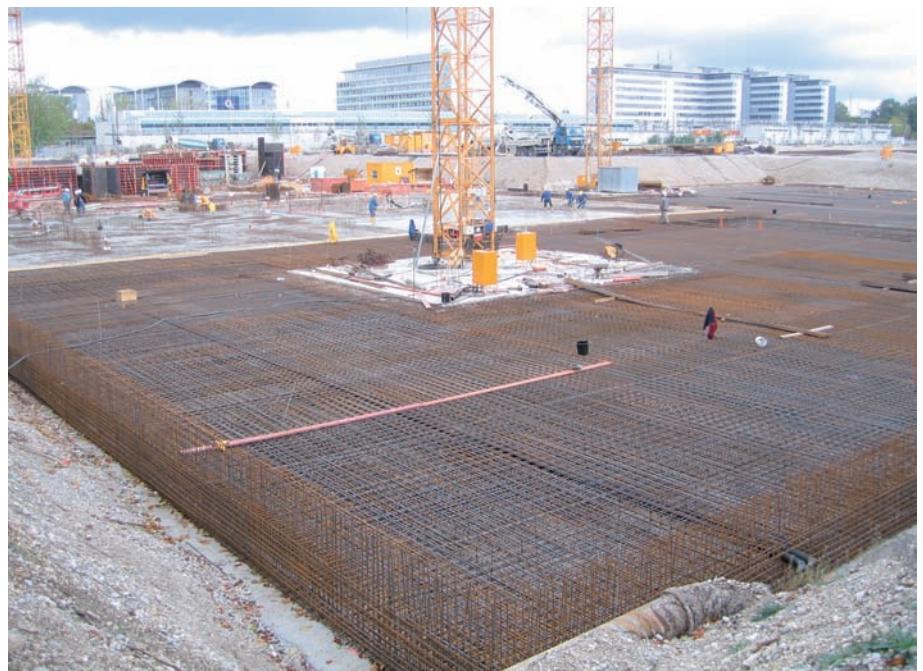
Fig. 10: Construction of a reinforced concrete structure
