Special Issue:
**Pipeline
Technology**

Fracture mechanical properties of polyolefins: Do the standards specify realistic areas of application?

By H.-J. Kocks, C. Bosch and M. Betz

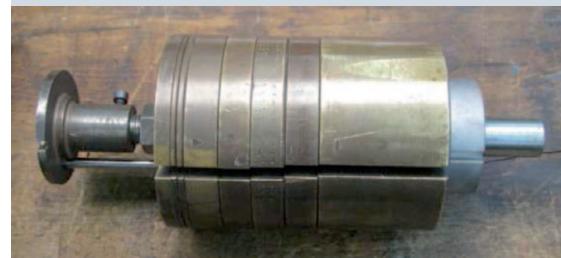
FIGURE 4: Drop weight used for modified impact testing

A flat area of impact would avoid this effect (Figure 4). The planar head of the drop weight used in this modified impact test has a diameter of 21 mm. A 10 kg weight was

dropped onto the surface from a height of 1.0 m. The impact energy thus computes as 98.1 J. In order to find a minimum temperature at which no cracks emerge, the test is repeated at different temperatures.

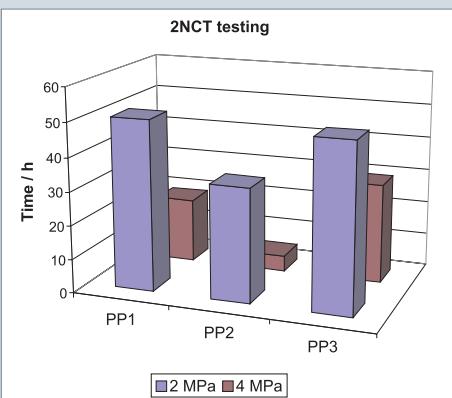
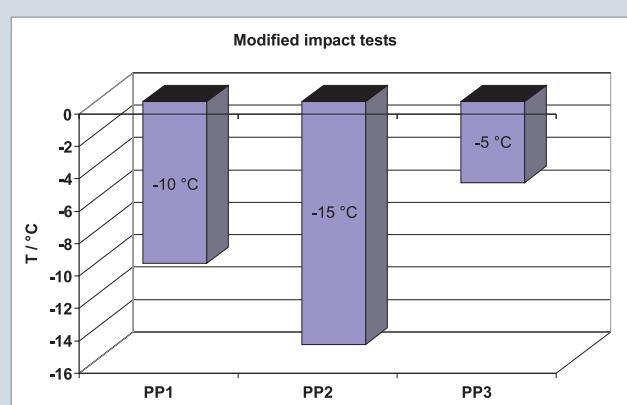
FIGURE 6: Results of modified impact tests on extruded sheets

Testing failed to find a correlation between the brittle points as assessed with modified impact testing and the results of the 2NCT. 2NCT test times were compared with the minimum temperatures used for the modified impact tests and found not to produce any cracking in the extruded sheets. The PP2 material yielded the worst in class 2NCT results. In the modified impact tests it did not start to crack until temperatures were below -15 °C. According to the modified impact test methodology, the other materials with significantly better 2NCT results have higher brittle points, i.e. below -5 °C and below -10 °C (**Figures 5 and 6**). Considering the fact that FNCT and 2NCT testing is performed at high temperatures, neither the change in these fracture mechanical properties can be measured nor a qualitative appraisal of the materials be provided.

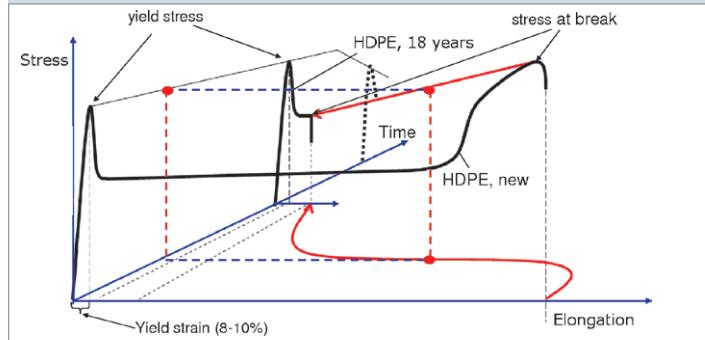
FIGURE 7: Comparison of tensile tests: Aging of HDPE

Investigations on the low-temperature embrittlement of polypropylene included mechanical tests helping to understand the causes. The tensile tests were carried out at different temperatures and confirmed interrelations found earlier in aged and, thus, embrittled polyethylene coatings [6]. Figures 7 and 8 illustrate (i) a comparison of tensile tests carried out on polyethylene coatings become brittle with age and non-aged material and (ii) the tensile tests carried out on polypropylene at room temperature and around the brittle points observed. Both samples not only show an obvious reduction in the elongation at break but also an unfavourable ratio of yield stress and tensile stress at break.

The only difference is the fact that the tensile stress at break of aged material is reduced compared to the yield stress, whereas, in the case of low-temperature embrittlement, the yield stress increases compared to the tensile stress at break. For aged polyethylene the yield stress stays on the level of the unaged material. In both cases yield stress and tensile stress at break reach an unfavourable constellation leading to a significant decrease of the elongation at break. Main requisite for crack initiation is that the yield strain or the yield stress is overrun. This critical point can be overrun in the whole material, e.g. due to tensions at temperature changes, or only in small areas, e.g. due to point loads and point support.

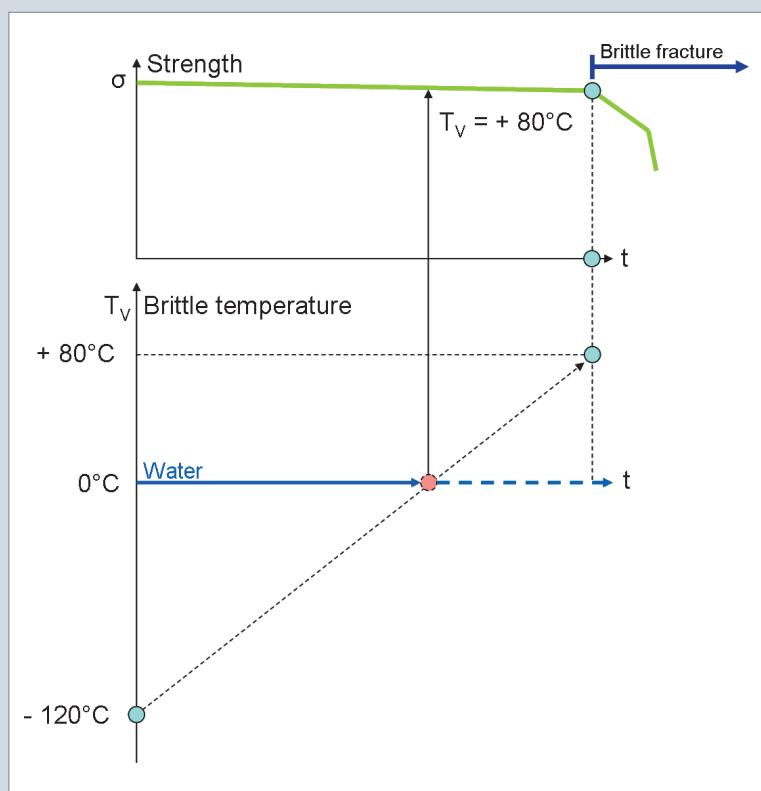
FIGURE 12: Brittling behaviour explained by way of an internal pressure creep rupture test

move closer to the yield stress, dropping temperatures will cause the yield stress to increase such that the brittle point is reached earlier. As temperatures drop, an aged material will thus be more susceptible to fracturing than a new material. For polyolefin based coatings in general only little information about creep-rupture behaviour is available. However, for polyolefin based pipes the creep-rupture behaviour is well known and should be transferable to polyolefin based coatings (Figure 12).

However, the brittle point of new material is far below 0 °C. If the glass transition temperature is assumed to be the starting point under the mainly quiescent load of an internal pressure test, said starting point is as low as -120 °C. Whereas there are hardly any changes to the material strength (yield stress) in this test, the brittle point shifts considerably if the starting and end points are taken into account. The actual course of the brittle point takes along the logarithmic time line currently remains unknown. This is why the course is shown as a dotted line in Figure 12.

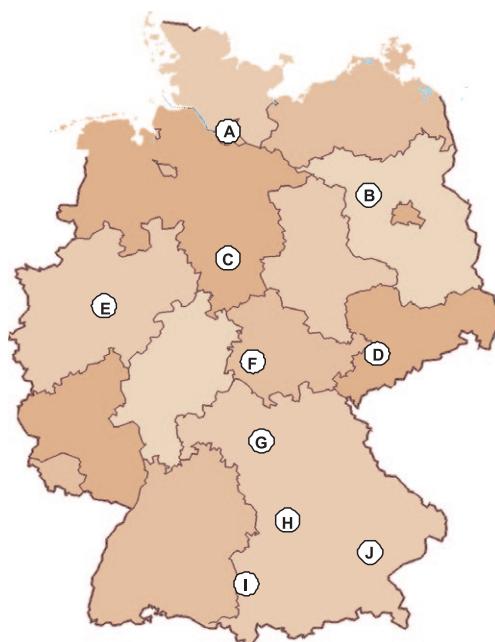
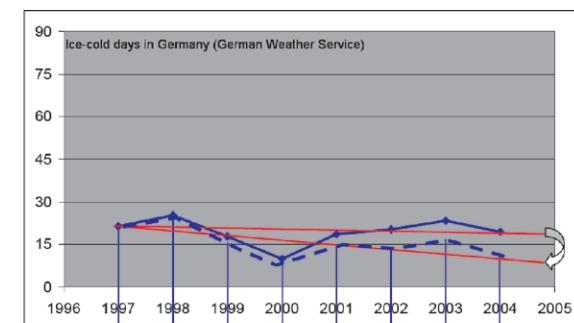
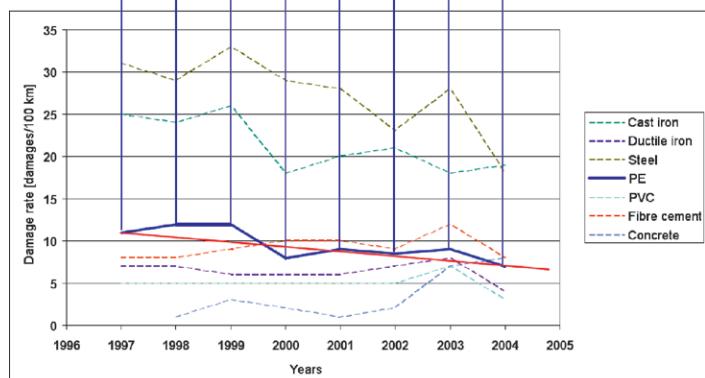
FIGURE 13: Comparison of climate data and the DVGW's claims statistics of PE pipe damages [7]

The comparison was based on the claims statistic published by DVGW (German Technical and Scientific Association for Gas and Water) [7] and the climate data published by DWD (German Weather Service) (Figure 13). How cold a winter was is judged by counting the number of ice-cold days. An ice-cold day defines as a day during which the temperature never rises above 0 °C. A large number of ice-
